Overview of Higginbotham Brook Watershed Project
Dam 1 in foreground & Dam 2 in background
Photo #1

PHASE I INSPECTION REPORT
NATIONAL DAM SAFETY PROGRAM
HIGINBOTHAM BROOK WATERSHED PROJECT
I.D. NO. NY 703
DEC #103C-4286
OSWEGO RIVER BASIN
MADISON COUNTY, NEW YORK

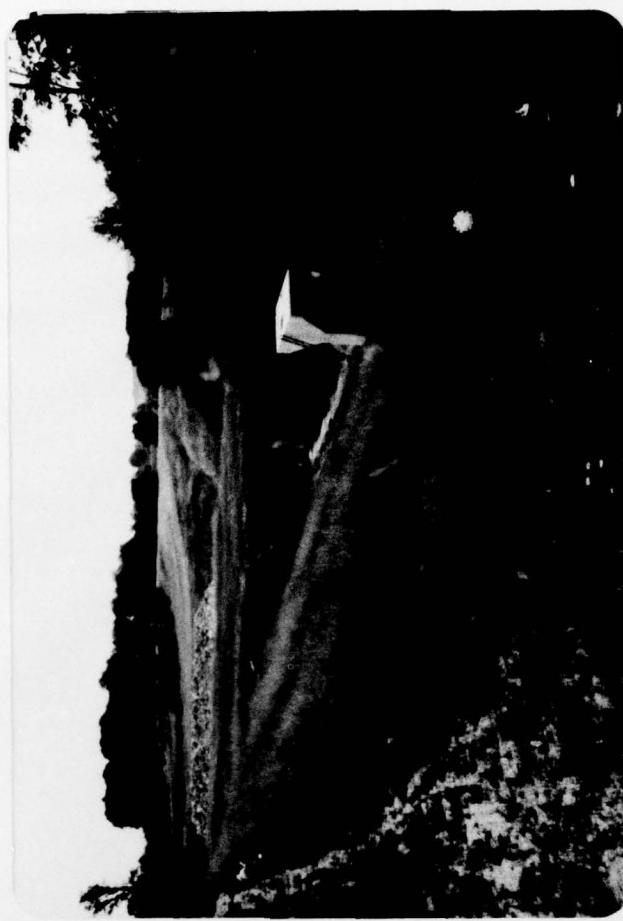
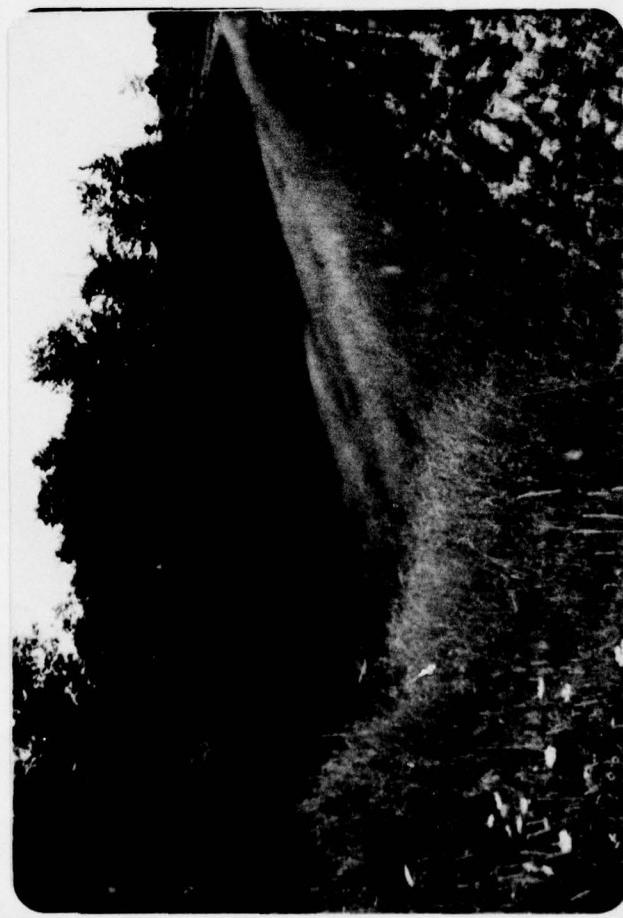
Dam 1
Photo #3 A & B

The principal spillway consists of a vertical drop inlet structure, a reinforced concrete pipe through the embankment, a plunge pool at the toe of the embankment, and an outlet channel. These components appear to be in satisfactory condition. (See photos #3, 7, 8 & 9)

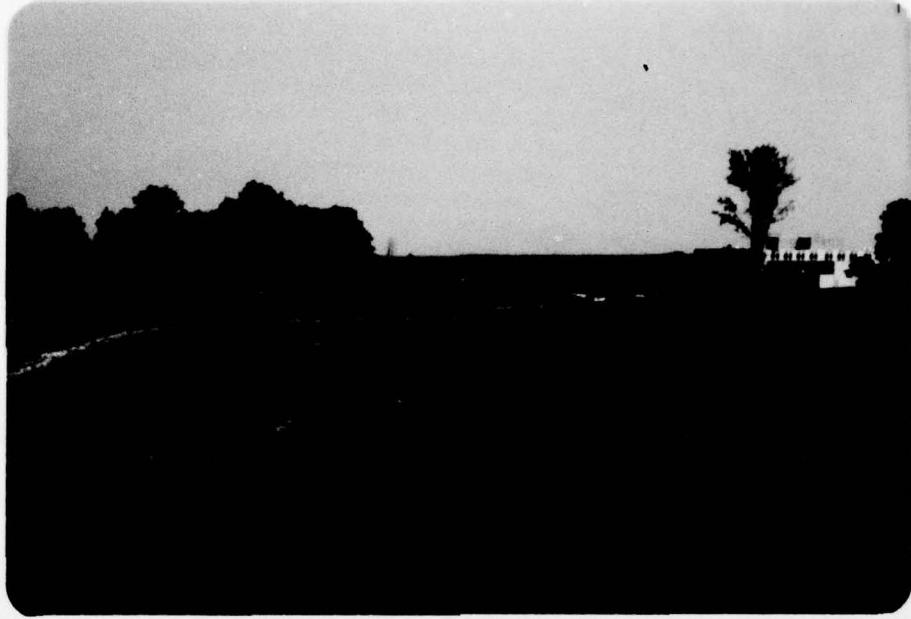
Dam 2 - Crest & Downstream Face
Auxiliary Spillway in Background
Photo #5

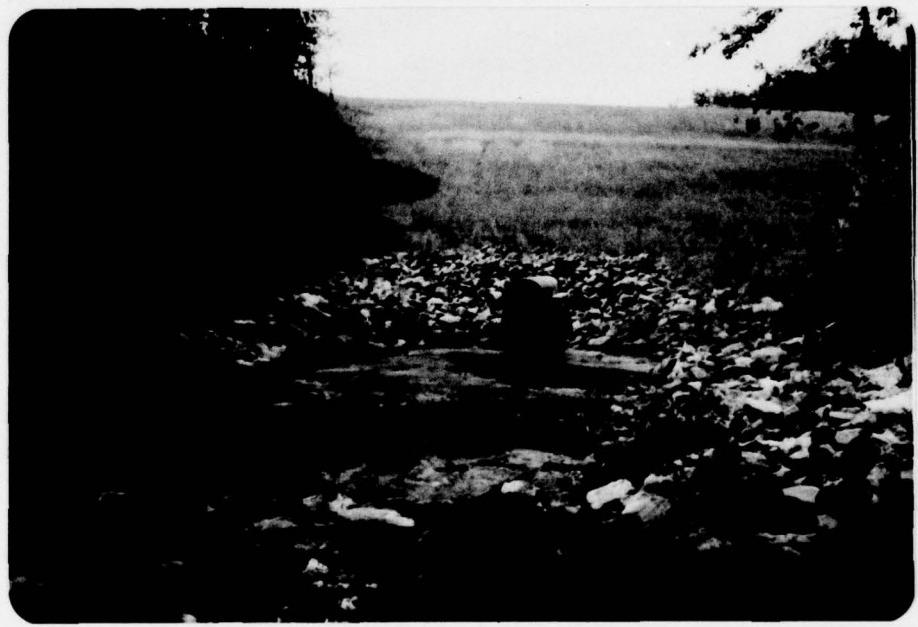
Two 8-inch diameter internal drains encased in a 2 zoned drain fill material provide control of the phreatic surface and foundation seepage. The left drain was discharging at a rate of approximately 3 to 5 gallons per minute. (See photos #8 & 9)

Dam 1 - Outlet of Principal Spillway Conduit
Photo #8

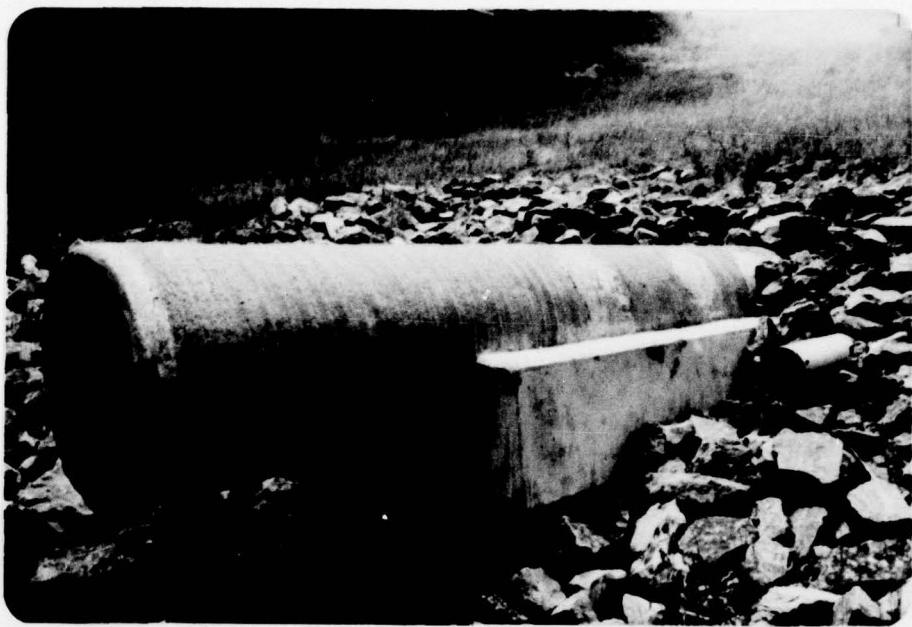
Dam 1 - Principal Spillway Conduit
Note Drainpipe
Photo #9

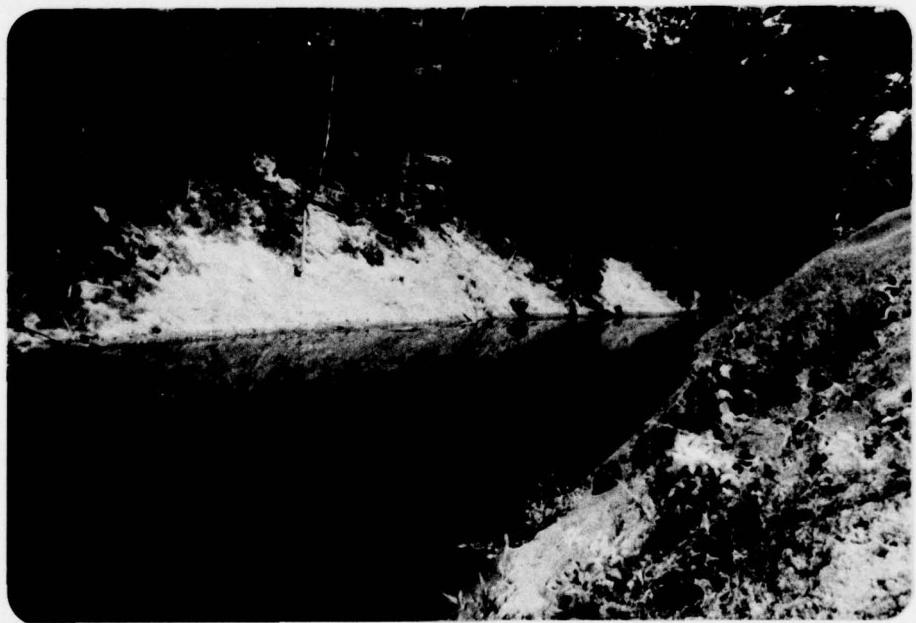
Steep Slopes in Reservoir Area
Note Shale Outcrop at Right
Photo #14
